RE: Esperanza Hills Project (Sch# 2012121071) DEIR #616

Please consider the following expert comments upon the Esperanza Hills Project EIR related to the Public Safety impacts of the Project.¹ The Project as currently proposed has significant adverse fire safety impacts that are not adequately mitigated to a level of insignificance.

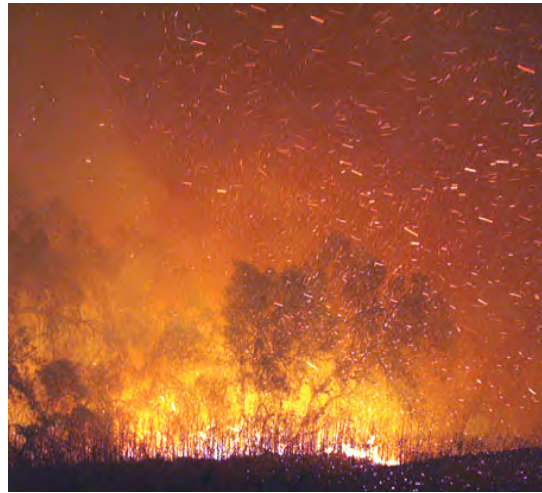
- Vulnerability of structures to embers/firebrands due to extreme events, human error, or inadequate maintenance (i.e., fire tornados or fire whirls,²⁸ broken windows from flying debris, drapes left over windows, open windows, open doors and garage doors, settlement cracks of structures built in landslide areas, wood piles, gas barbeques and motor-homes and other flammables stored too close to structures, delinquent or inadequate fuel treatments).

Wind-blown embers

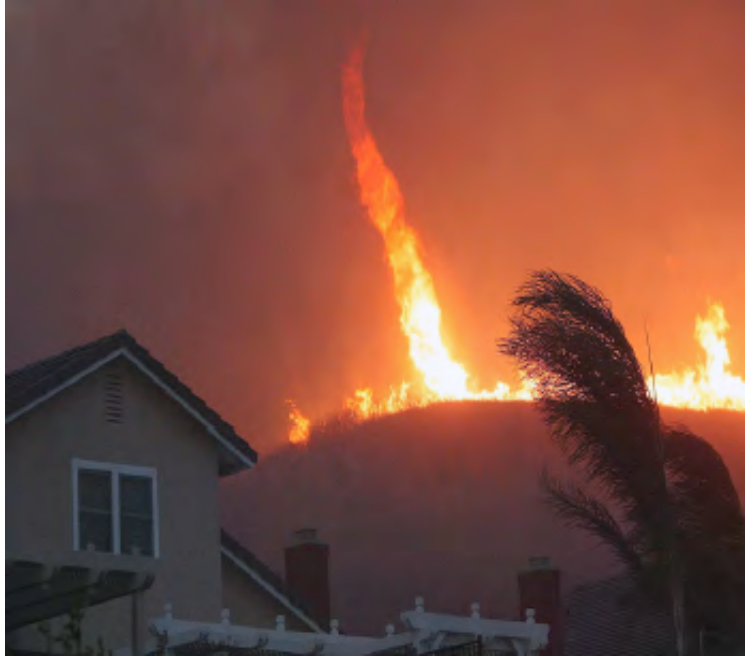
Attic vent vulnerable to embers within a fire tornado.

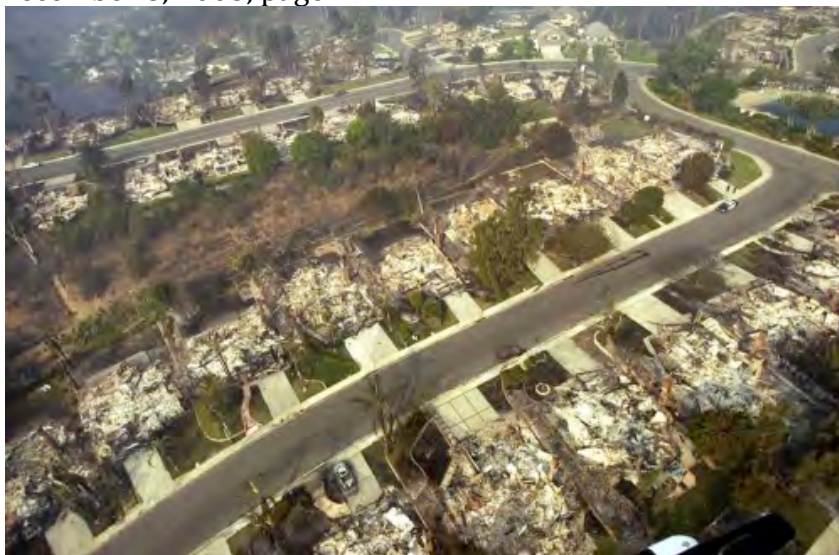
- Vulnerability of adjacent homes and the entire development from flame impingement and radiant heat once one or more homes are ignited from embers/extreme events or human error. There remains significant fire risk of structures within 100-feet of each other to cluster burn (especially those with north to east wildland interfaces).²⁹

Cluster burn example from Cedar fire. Photo by John Gibbins, SDUT.

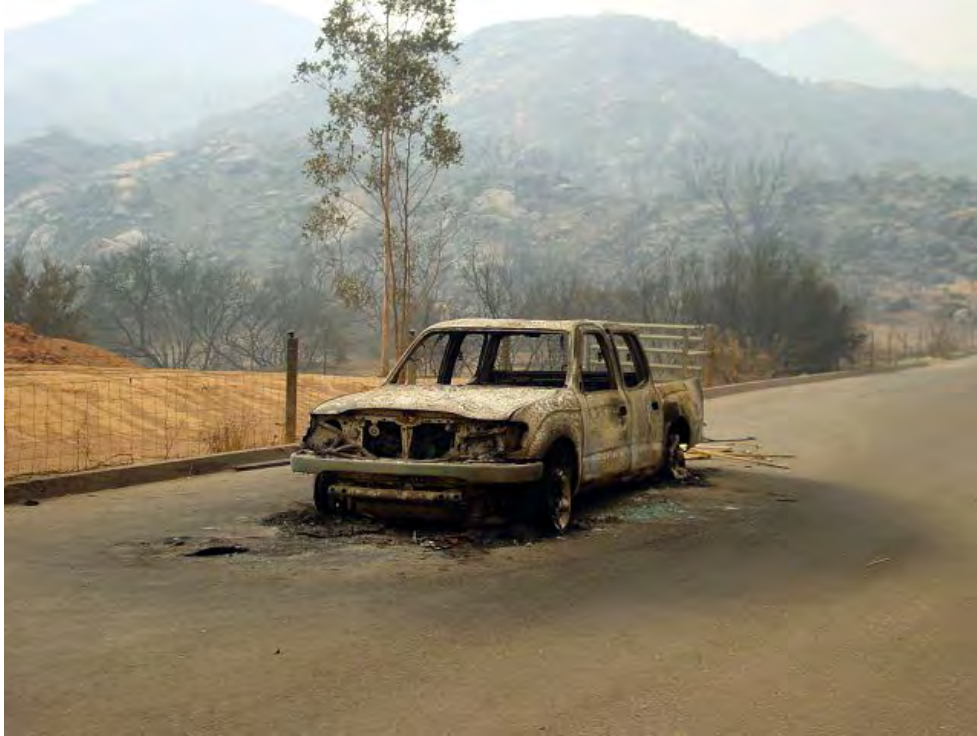
distance from flames may not be sufficient to prevent injury or death if there is severe convective heat transfer.³⁷ For example, an expected flame length of 100 feet would require a safety zone with a radius of 400 feet from the fuel. 400 feet would likely be insufficient if the available safety zone was sited in, near or above steep topography that funnels convective heat.

Cedar Fire victim perished in area of wide clearance.

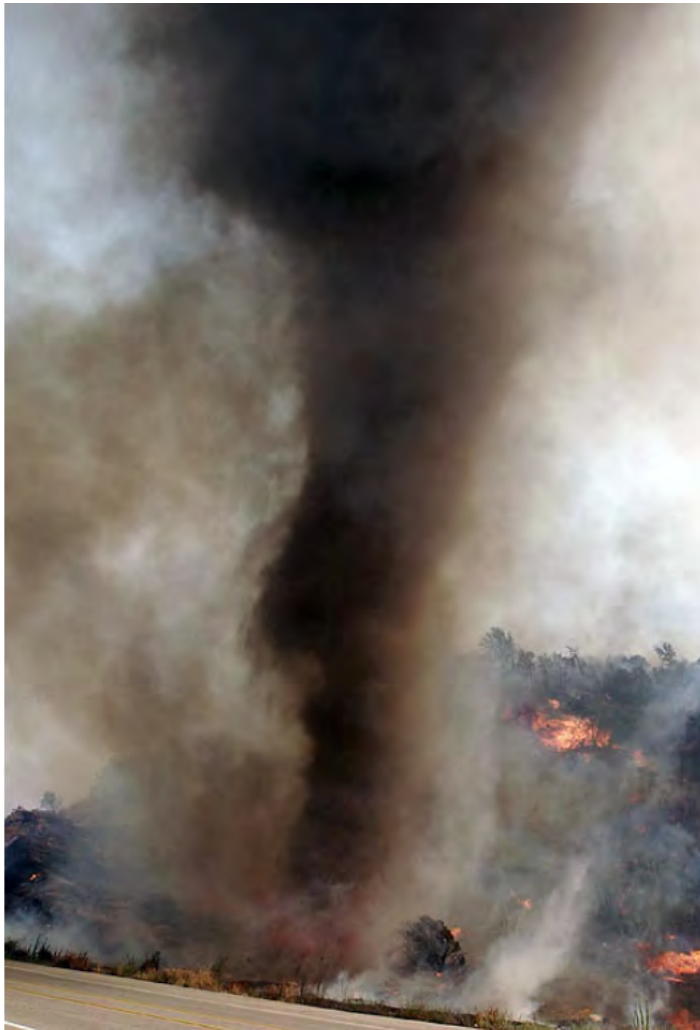
Convective Heat / Fire Whirls Pose Extreme Danger

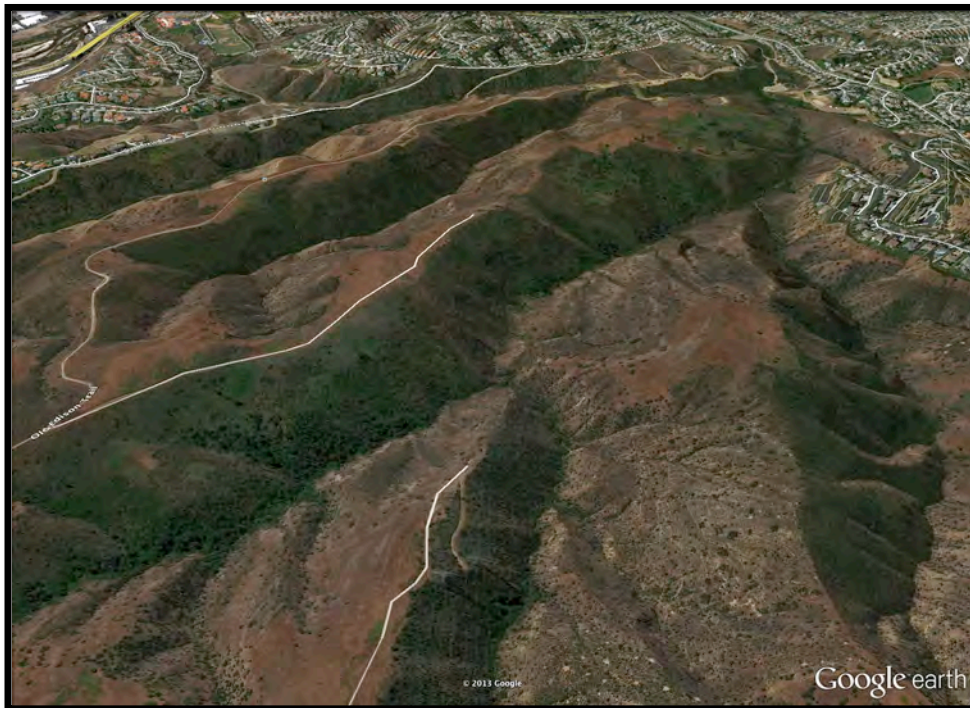
Fire vulnerable topography of the Project site viewed from the northeast.

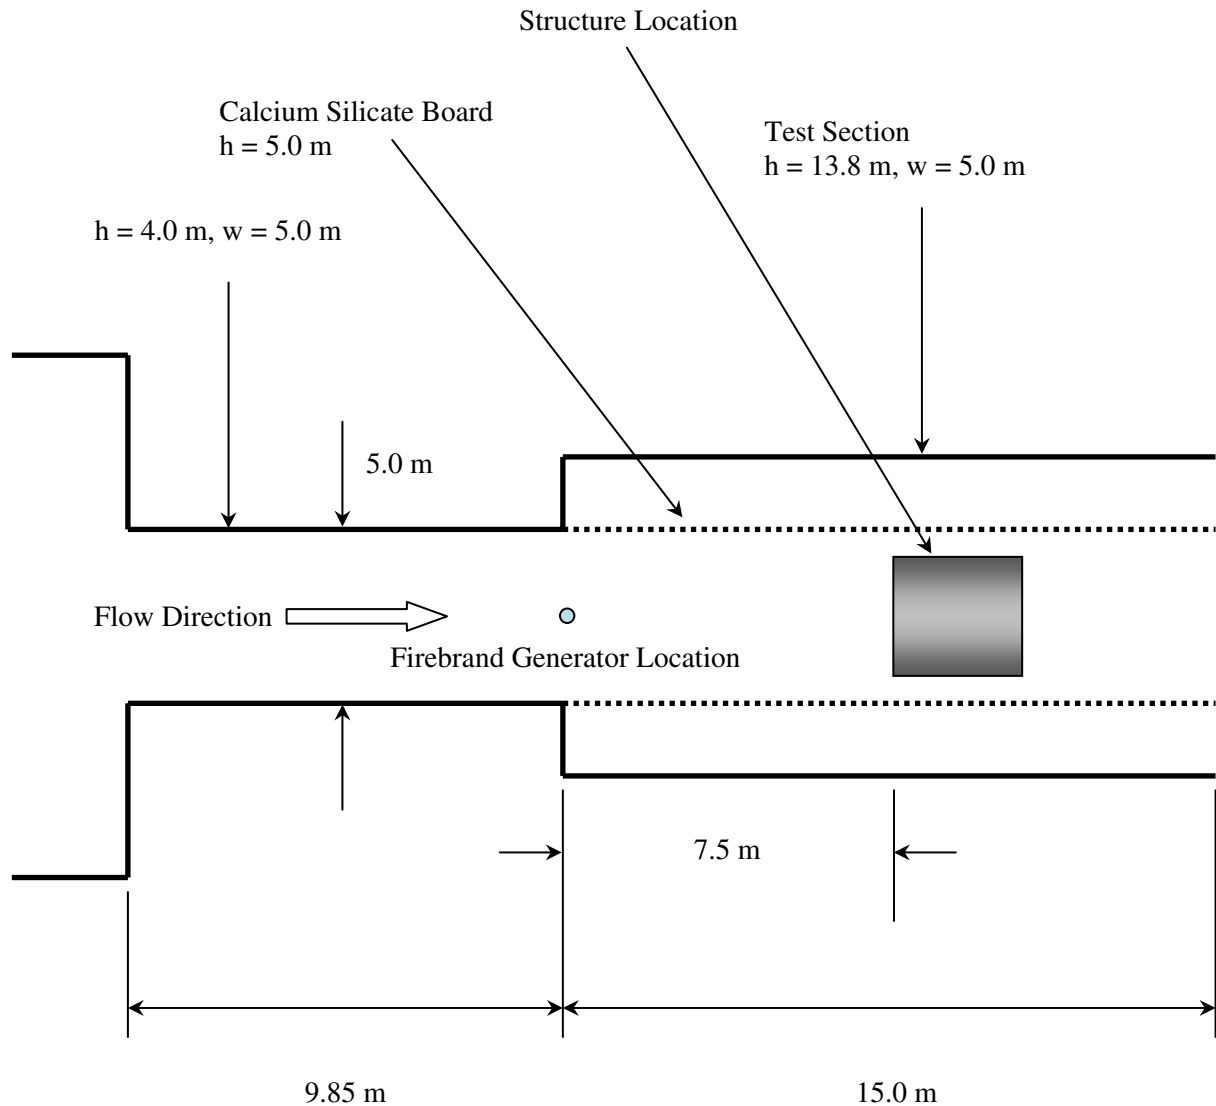
After the generator was characterized, the structure used for vent penetration experiments was installed inside the FRWTF (see Figure 2). Prior to conducting the experiments, computer simulations were performed using the NIST Fire Dynamics Simulator (FDS) to help guide the location of the structure with respect to the firebrand generator. Figure 3 is a detailed drawing of the front face of the structure, showing the location of the gable vent. The overall dimensions of the structure were 3.06 m in height, 3.04 m wide, and 3.05 m in depth. A common type of gable vent, 30.5 cm wide by 45.7 cm long, was used. Experiments were conducted using the same vent but modifying the screen placed behind the vent. Three different screen sizes were used, 1.5 mm, 3 mm, and 6 mm. The justification for these sizes is provided below.

Figure 2 Drawing of the FRWTF (Top View). The location of the firebrand generator is shown.

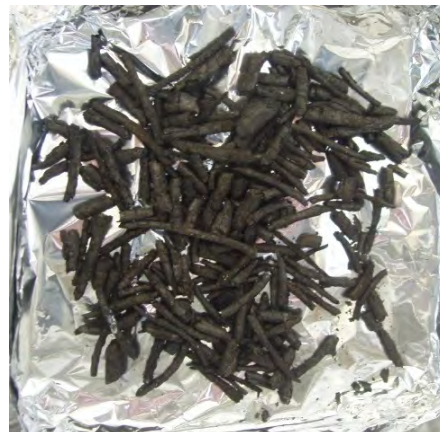
Accordingly, the input conditions for the firebrand generator were intentionally selected to produce firebrands with mass classes up to 0.4 g. This was accomplished by sorting the Korean Pine tree mulch using a series of filters prior to being loaded into the firebrand generator. Figure 4 displays a picture of typical firebrands produced from the firebrand generator under these conditions. Since many of the firebrands produced are cylindrical, the length and diameter of the generated firebrands was measured. This information was then used to calculate the surface area of the firebrands produced and was plotted as a function of the measured firebrand mass (see Figure 5). Figure 5 also displays the same analysis performed for firebrands collected from Douglas-Fir trees as well as Korean Pine Trees under similar moisture content. From the figure, the firebrand generator was capable of producing the size and mass distribution of firebrands from burning trees up to 0.4 g.

Figure 4 Digital picture of the firebrands produced from the firebrand generator. These images are taken after the firebrands were extracted from the water filled collection pans and dried.

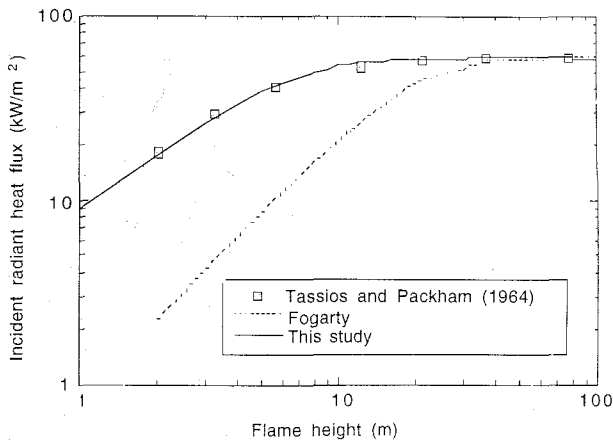
Webster (1986) presents work by Tassios and Packham (1964) that discusses theoretical values of incident radiant heat on a firefighter. They predict a maximum heat flux of 60 kW-m⁻² incident on a firefighter standing 6 m from a 21 m tall flame. Fogarty (1996) combined work reported by Leicester (1985) and Thomas (1963) to develop a model that predicts incident radiant energy on firefighters as a function of fireline intensity and distance from

Figure 2. Comparison between previous models and that presented in this study. For this comparison we assumed a flame temperature of 1200 K and flame width of 20 m, the firefighter was approximated as a flat surface 1 m wide by 2 m tall located 6 m from the flame.

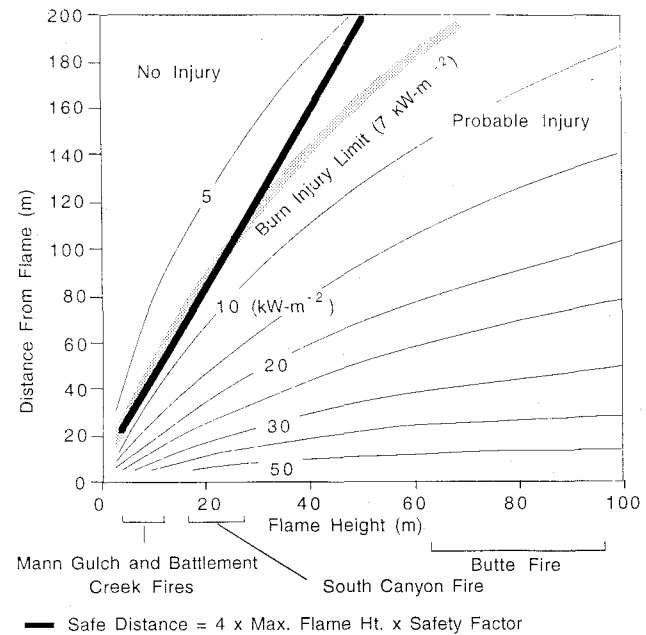
The Battlement Creek Fire occurred in western Colorado during July, 1976 (USDI/USDA 1976). The fire burned on steep slopes covered with 2 to 4 m high *Quercus gambeli* (Gambel oak). Flames were estimated to be 7 to 10 m above canopy. Four firefighters were cut off from their designated safety zone. When the fire overran them, they were lying face down on the ground without fire shelters in an 8 m wide clearing near the top of a ridge. Tragically, only one of the four survived, and he suffered severe burns over most of his body. Figure 3 suggests that for this fire, a minimum safety zone size is 40 m, with 55 m being preferable. Clearly, the 8 m wide clearing did not qualify as a safety zone.

Figure 3. Lines represent predicted net radiant heat flux to a firefighter as a function of flame height and distance from the flame. It is assumed that the firefighter is wearing fire retardant clothing (Nomex) and protective head and neck equipment. Heavy shaded line represents burn injury threshold (7 kW-m⁻²).

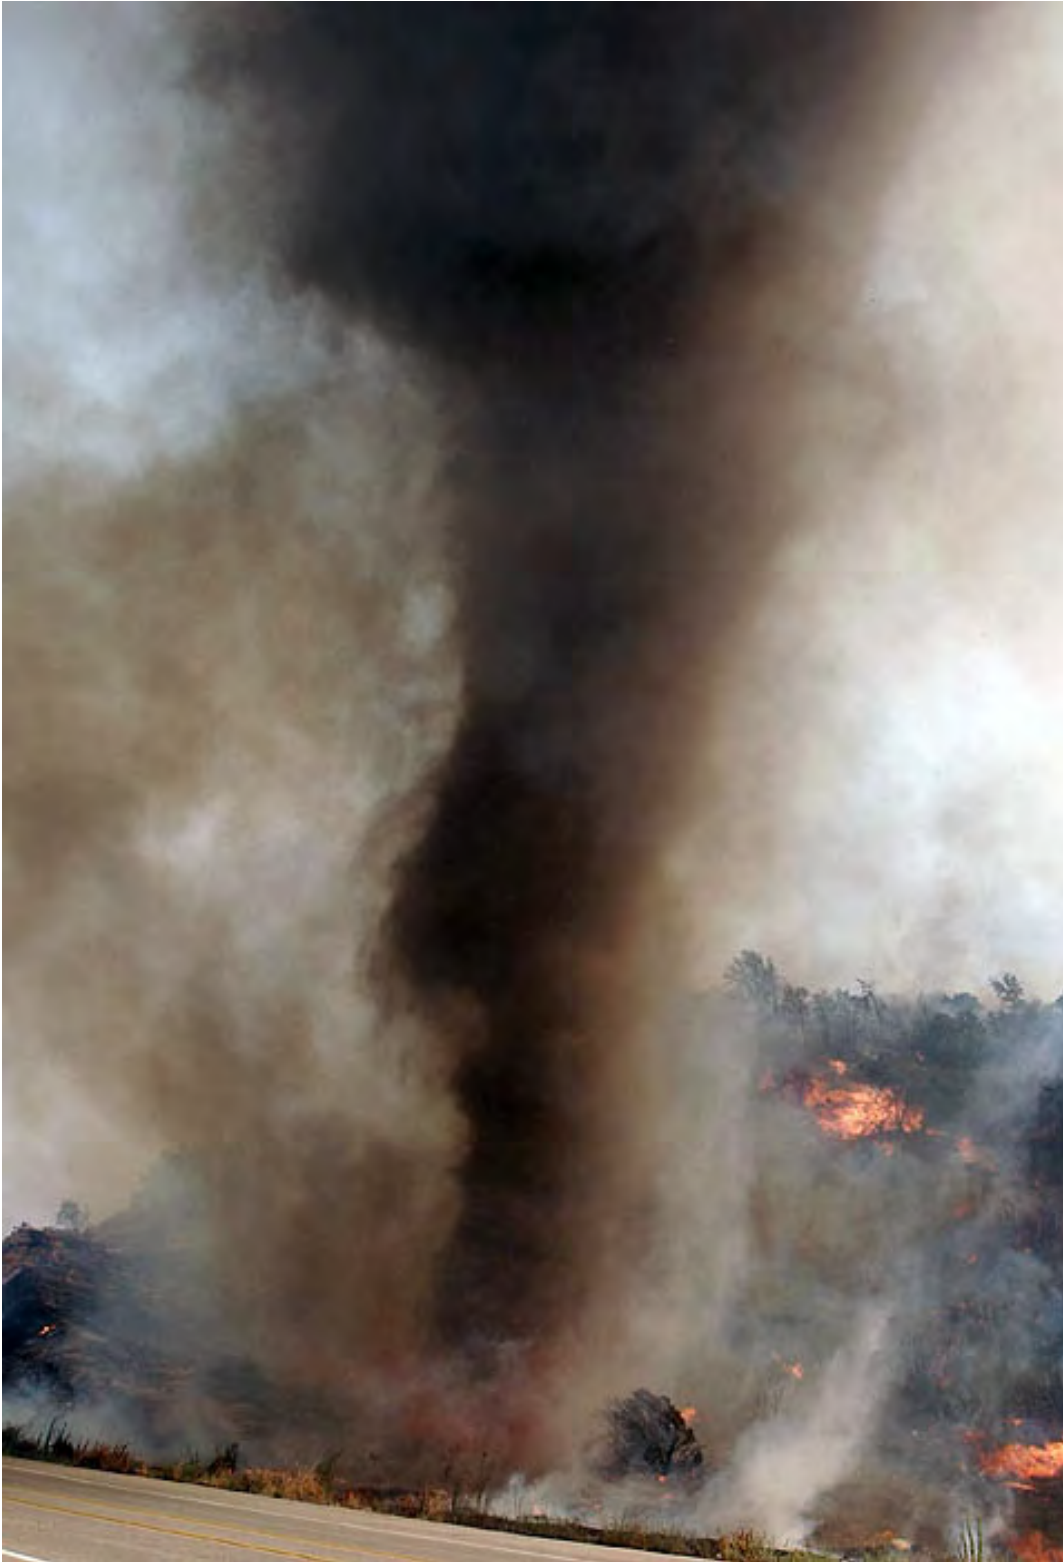
Exhibit 1: Rock Point Peninsula - No Safety Zones due to Radiant and Convective Heat potential of southern mixed chaparral (SMX Fuel Model 4) adjacent fuel loads.

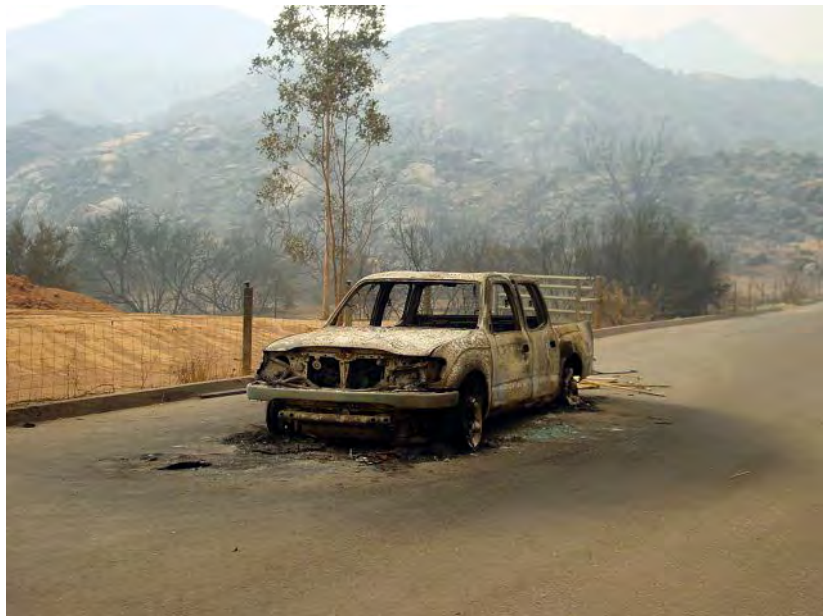
Cedar Fire Fatality Despite Clearance

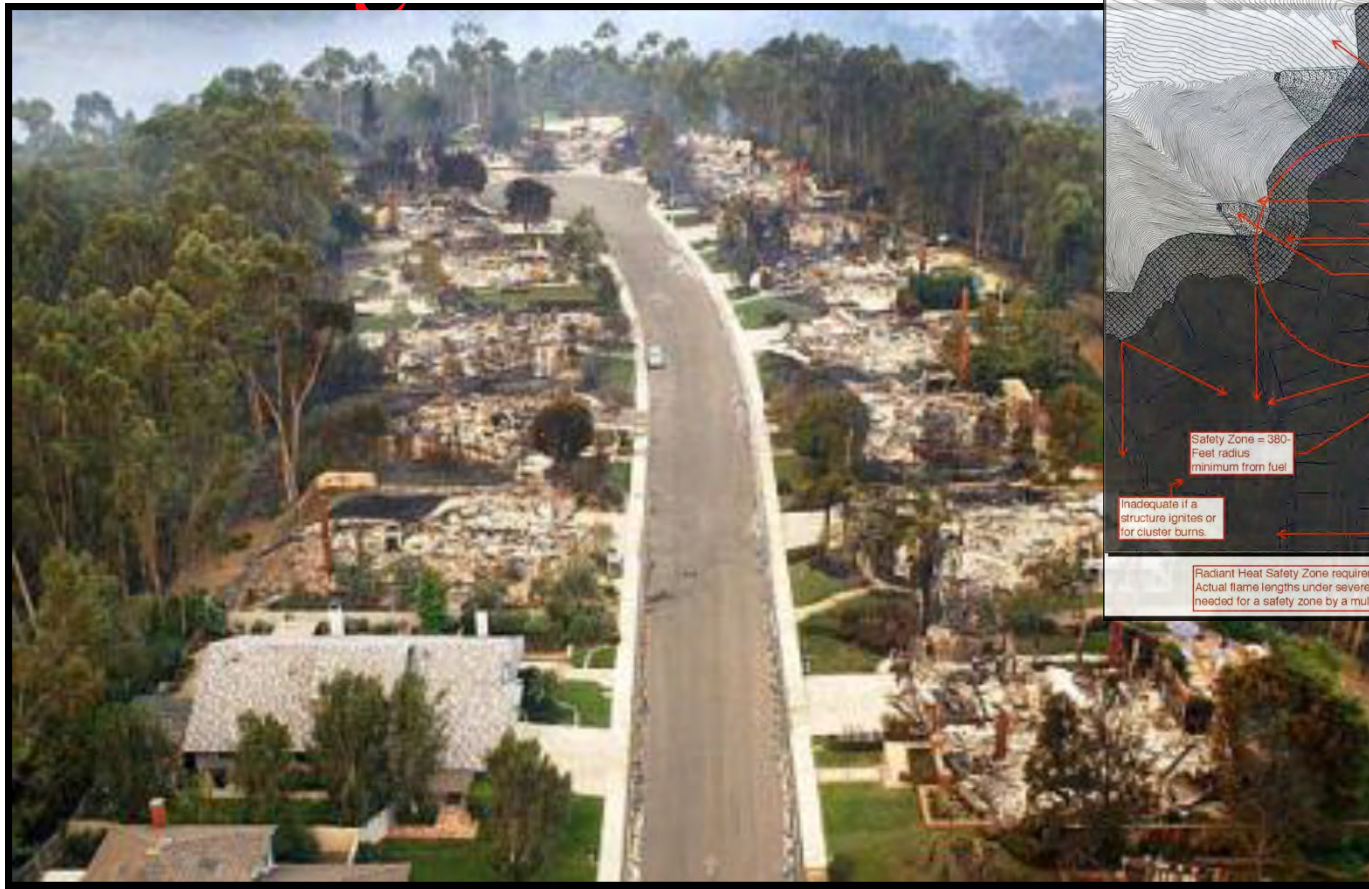
Cluster Burn Hazard

Wider Lots on the WUI could Reduce the Risk of Cluster Burn

Narrow Lots generally 70-105 Feet

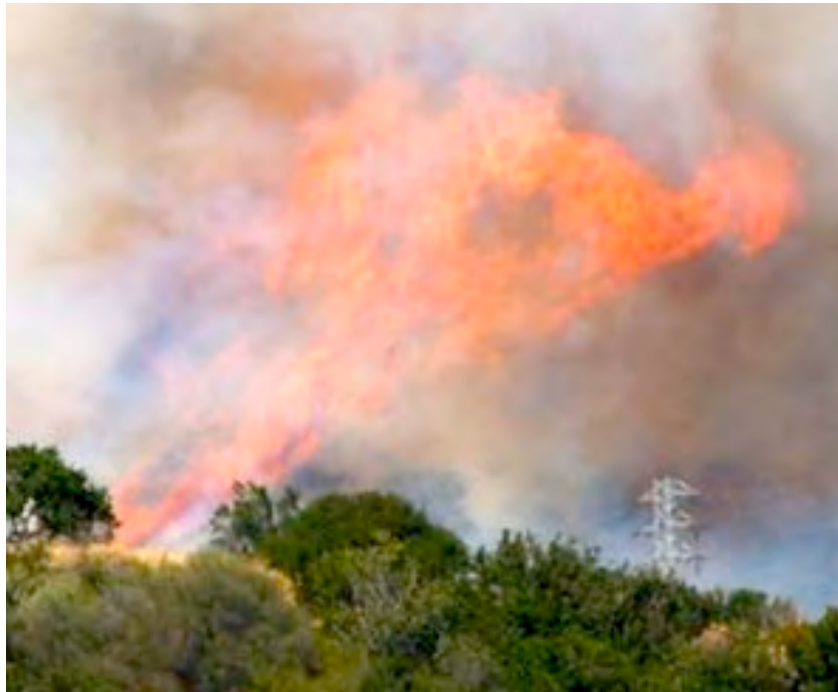
“An FM-4, chaparral vegetation greater than 6-feet in height, provides the greatest rates of spread and energy release with flame length **usually exceeding 100 feet**. Wildfires burning under Santa Ana wind conditions in this type of vegetation are the most destructive and difficult to control.”

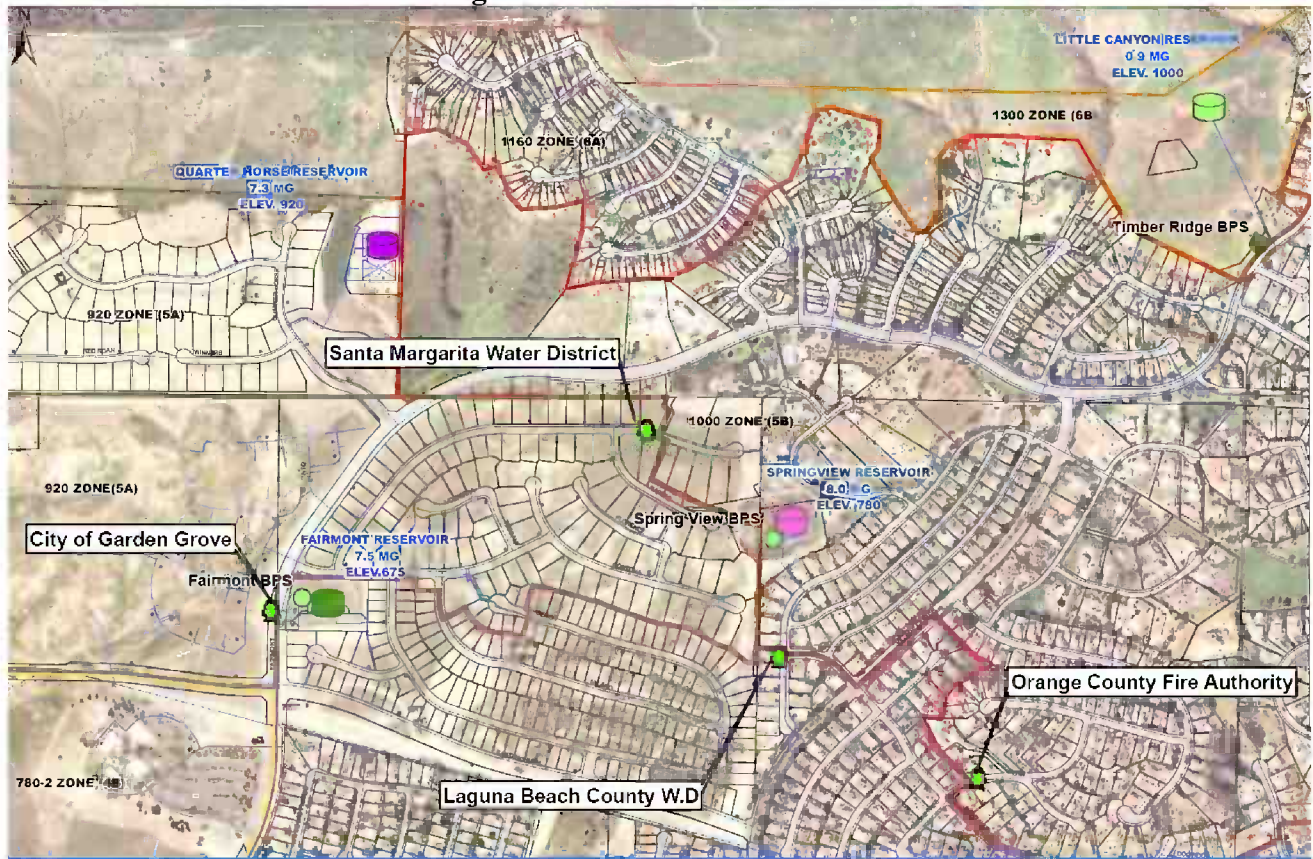
Figure 11-1: Mutual Aid Locations

4. **City of Garden Grove Fire Department** – A secondary fire pumper truck arrived at 6:50 p.m. and was dispatched to Fairmont Pump Station to augment water supplies from Area 6 (Springview Reservoir) to Area 8 (Little Canyon Reservoir).

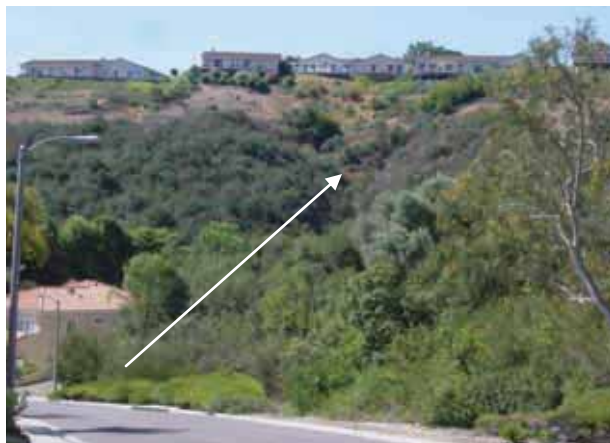
Although fuel modification and defensible space provisions are typically applied at the perimeter of a development—the “edge” of the WUI, homes on or near interior slopes are also at risk. The vegetation in these areas should also be managed to reduce the risk of home loss from fires.

Arrow pointing to an overgrown interior slope prior to the Freeway Complex Fire

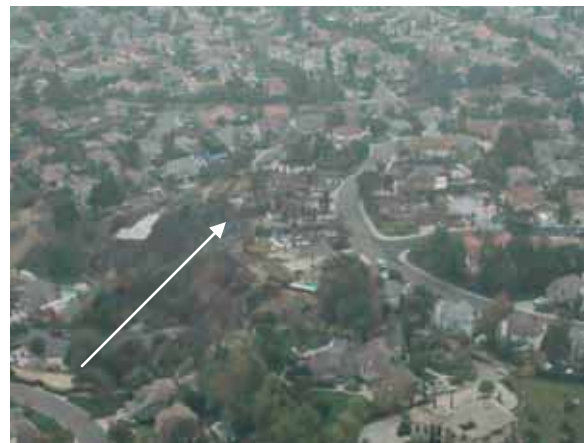
Arrow pointing to the same slope after the Freeway Complex Fire showing the tragic loss of homes along the ridge

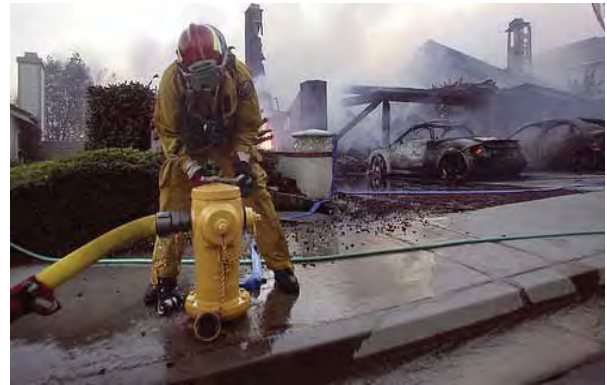
Getting water for structure protection

During the Freeway Fire, the demand for water by the structure protection engines exceeded the available supply. Areas of Yorba Linda, such as Hidden Hills, had loss of water pressure during which firefighters had to shuttle water from other areas. As defensible space and ignition construction have been studied over the years, so to have been the water needs in the WUI. New standards have been drafted and are available for local adoption.

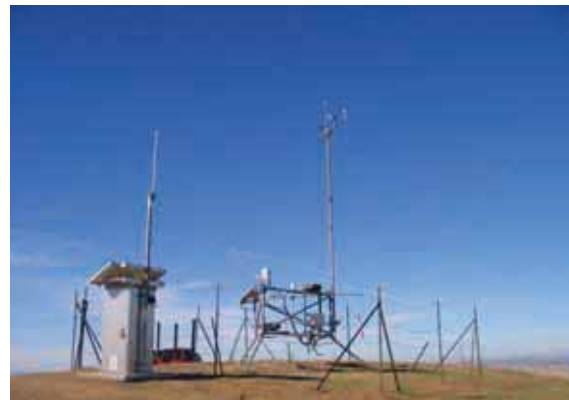
Table 6: Freemont Canyon RAWs—Santa Ana Mountains

Time	Temperature (°F)	Wind Speed/Gust Speed (mph)	Relative Humidity (%)
9 a.m.	75	43/61	8
3 p.m.	80	25 /45	7

In **Table 6**, Freemont Canyon RAWS indicated responding personnel had to contend with mild temperatures of 75°F, low relative humidity of 8 percent, and strong east/northeast winds sustained at 43 mph, gusting up to 61 mph. Winds were higher than expected based on the recent National Weather Service (NWS) predictions and morning briefing on statewide fire conditions.

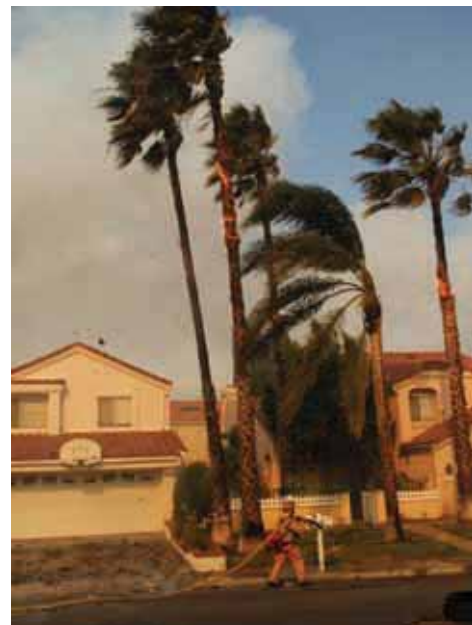
Palm trees show how strong the wind blew during the fire

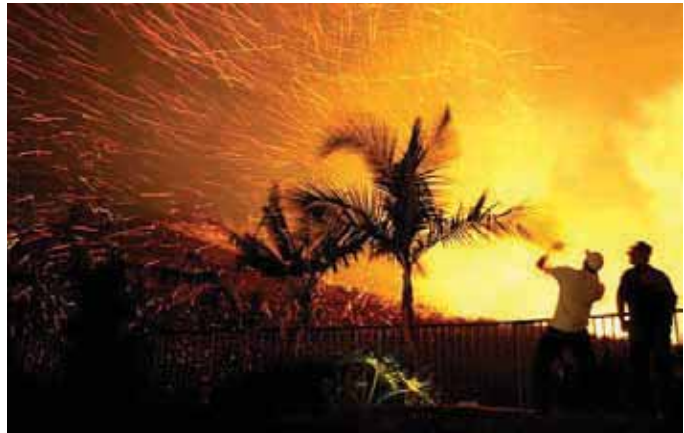
Ember shower in advance of flame front.

In Yorba Linda, decorative vegetation, palm trees, and even ground cover on center medians served to fuel the fire's progression. Embers were driven into attic vents, underneath roof tiles, and into any unprotected openings. Firefighters employed a firefighting tactic known as "bump and run"—moving from home to home and street to street after knocking down visible fire. Dispatchers continued to relay reported structure threats to the Operations Section Chief, and available units were deployed.

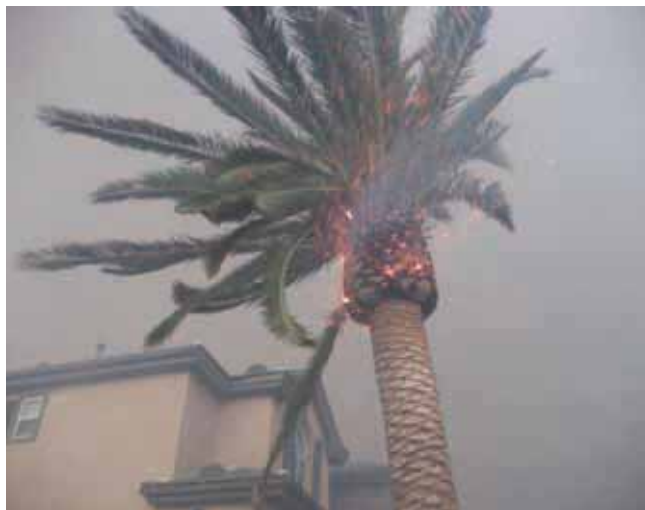
Palm tree ignites by flying embers.

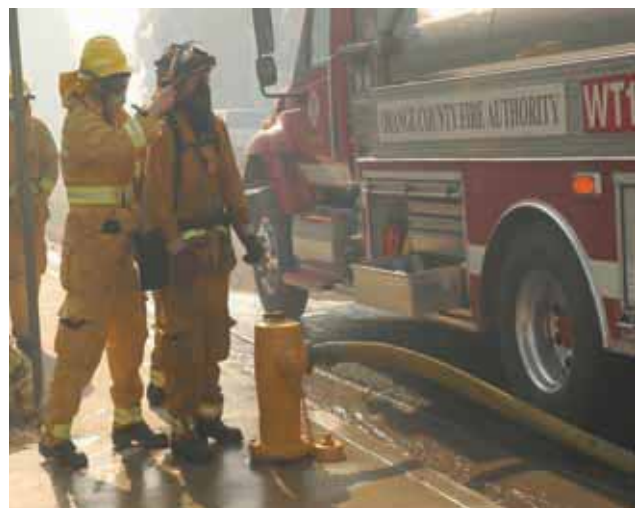
Firefighters fill a Water Tender at a lower elevation to take to engines fighting fires at higher elevations due to the lack of hydrant pressure.

water, strike team leaders directed engine companies to move to areas that had available water. However, because the Patrol/CAFS task force was supported by the water tenders, it was able to effectively operate with less water than that required by an engine. Unfortunately, due to rapidly diminishing water pressures, even the water tenders were driven further down the hill to be refilled. These resources remained in the Hidden Hills community to protect houses that had not burned and to ensure extinguished homes did not rekindle. The availability and use of the CAFS was a direct result of recommendations made in the 2007 Santiago Fire After Action Report.

The water supply issue was reported to the Yorba Linda Water District (YLWD) through the City of Yorba Linda EOC at approximately 2:00 p.m. YLWD personnel responded to the area and were able to make adjustments to improve the water delivery in several areas. Due to the fire threat, water district personnel were unable to access the Santiago booster pump station. When YLWD personnel were initially able to make access to the pump station, they determined there had been sufficient heat to cause the pump station for the Santiago Reservoir to automatically shut down.

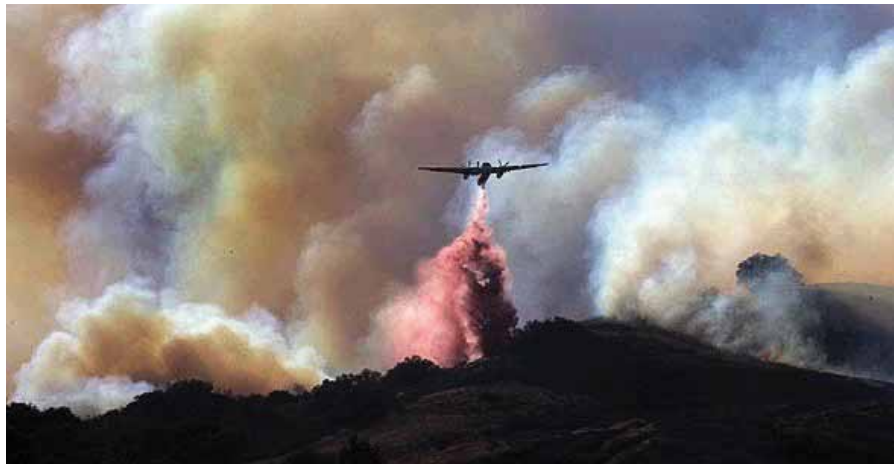
Air Tanker dropping retardant along a ridgeline

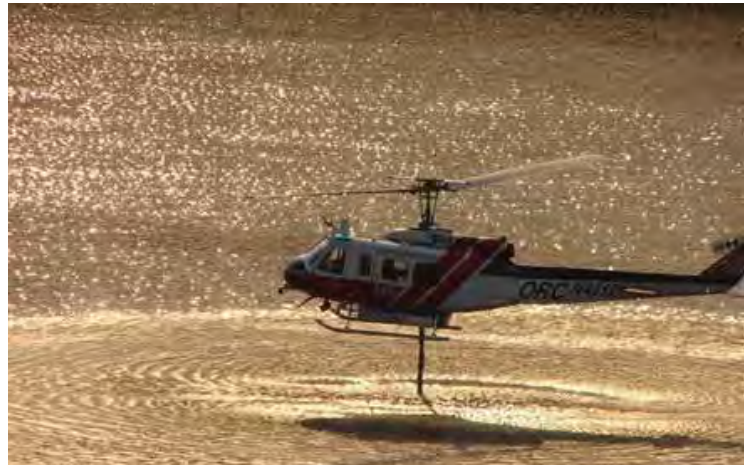
OCFA helicopter uses a snorkel to refill its water tank.

deploy its 170-gallon bucket prior to engaging in the firefight. Duke 1 and the ORC helicopters were initially using the lake and water hazards of the Green River Golf Course as their water source. The buffeting wind soon made hovering to fill the bucket and water tanks too hazardous. A ground-based water point was established, so the helicopters could land and be filled safely.

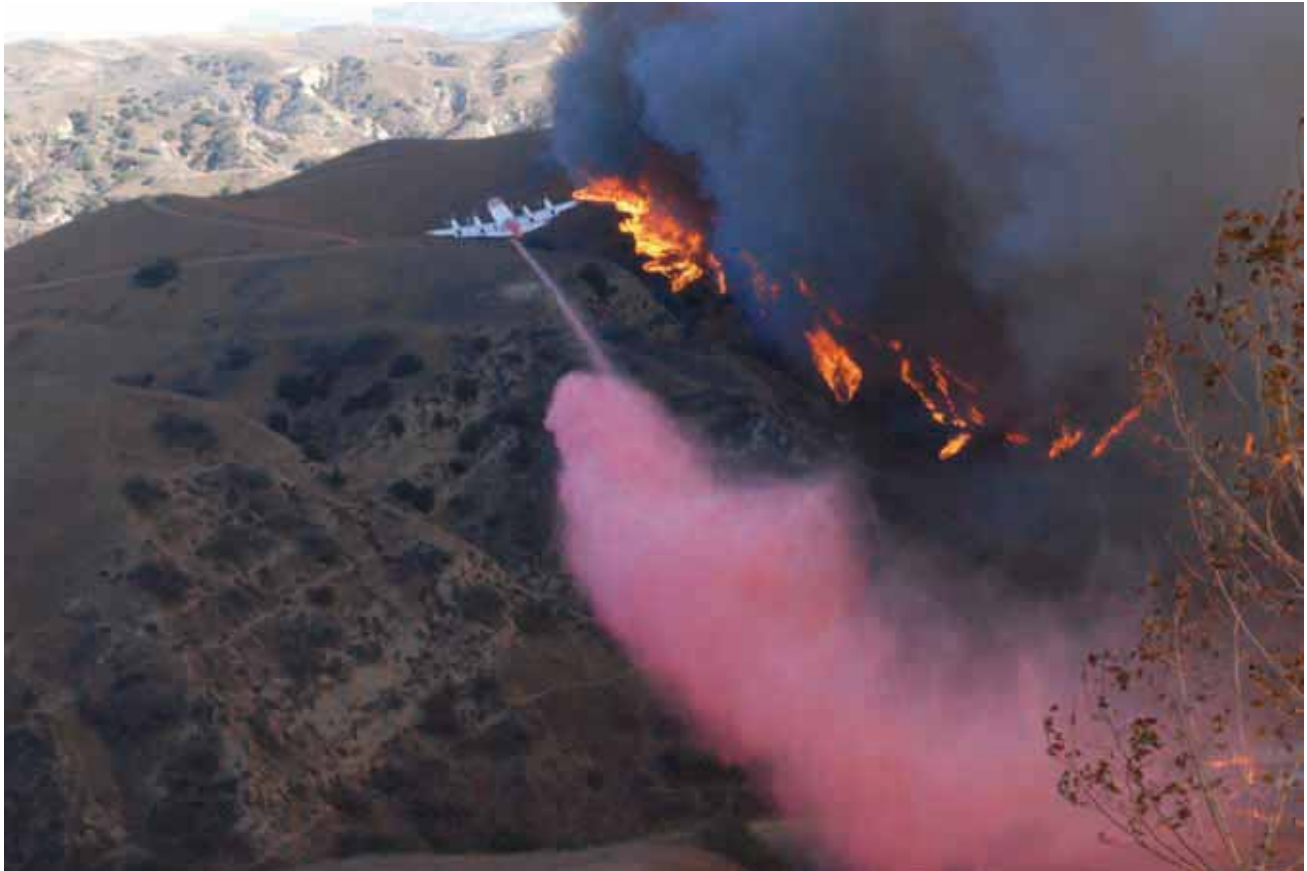
Air tanker lays a retardant line in front of the fire to slow its forward progress.

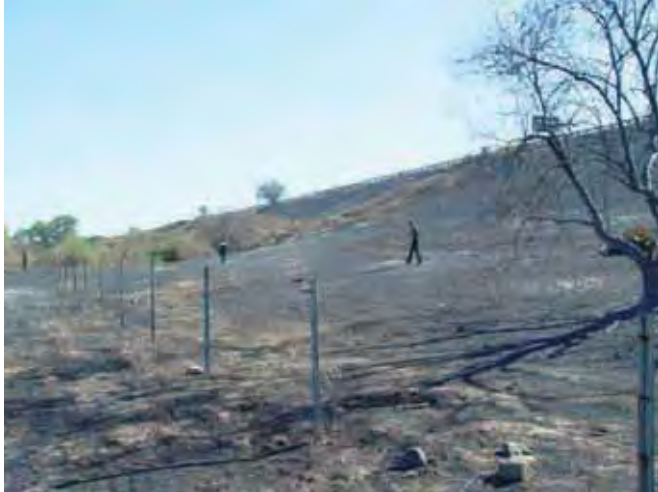
The Freeway Fire originated in Riverside County near the 91 Freeway and the Green River off-ramp in the City of Corona. The area of origin is the jurisdiction of CAL FIRE; therefore, CAL FIRE investigators assumed the responsibility for the fire investigation. The preliminary fire cause is reported as accidental. The preliminary cause may be the result of a vehicle exhaust system igniting roadside vegetation. The fire investigation report is expected to be complete by the end of March 2009.

CAL FIRE arson investigators search the area of origin of the Freeway Fire for evidence.

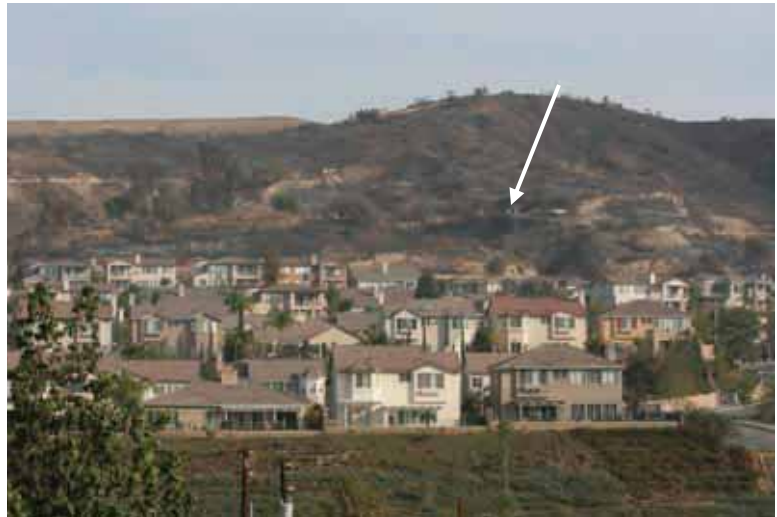
The Landfill Fire, investigated by the Brea Police Department along with investigators from the OCFA, was determined to have been caused by inadequate maintenance of power lines supplying electricity to equipment in an oil field. The electrical lines are owned by Breit-Burn Management Company in Los Angeles. Investigators believe arcing or a discharge of current from the power lines caused the brush near the lines in the fields northeast of Valencia Avenue and Carbon Canyon Road to ignite.

The origin of the Landfill Fire is seen behind the homes in the City of Brea.

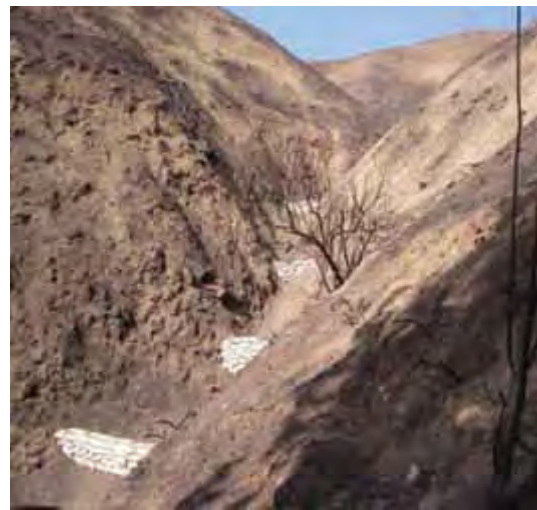
Sand bags in place west of Banyon Rim.

The BART report provides mitigations to reduce—but not entirely eliminate—risk from the identified hazards. Suggestions such as straw mulching and erosion control fabric or blankets, straw wattles to provide a mechanical barrier to water flow and trap sediment, hydro-mulching in selected areas, and K-rails to direct water run-off, if used properly, are very effective.

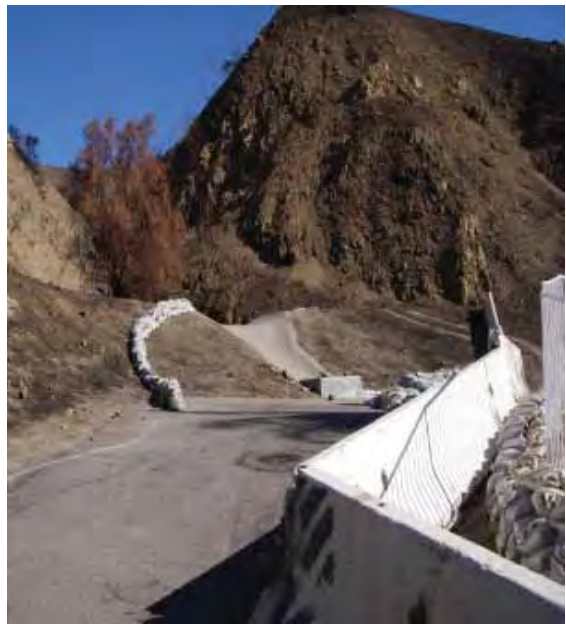
Use of K-rail to channel future debris flow around homes.

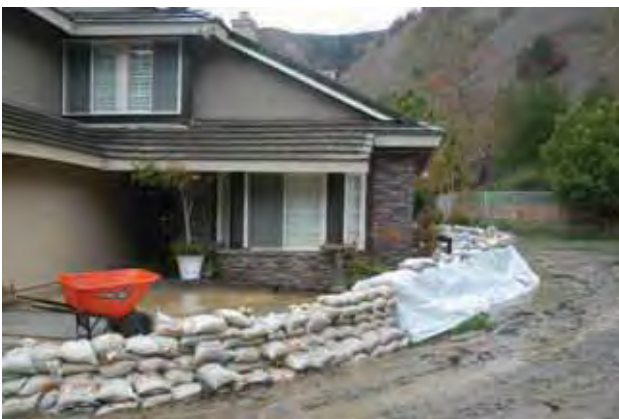
Resident's preparation for possible mud and debris flow proved to be beneficial.

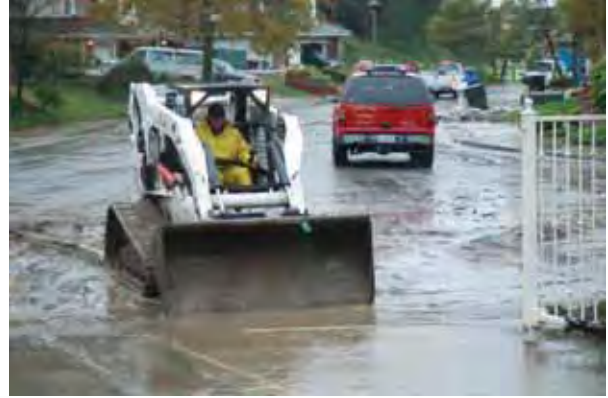
Dozer clearing mud off the street following the rains that hit the fire consumed areas of Yorba Linda.
